FLIGHTLINE THERMAL ENVIRONMENT TESTING OF F-111 TRANSPARENCIES

Robert J. Simmons, 1Lt, USAF
Advanced Development Branch
Vehicle Equipment Division

July 1983

Final Technical Report for Period 1 November 1979 - 20 August 1981

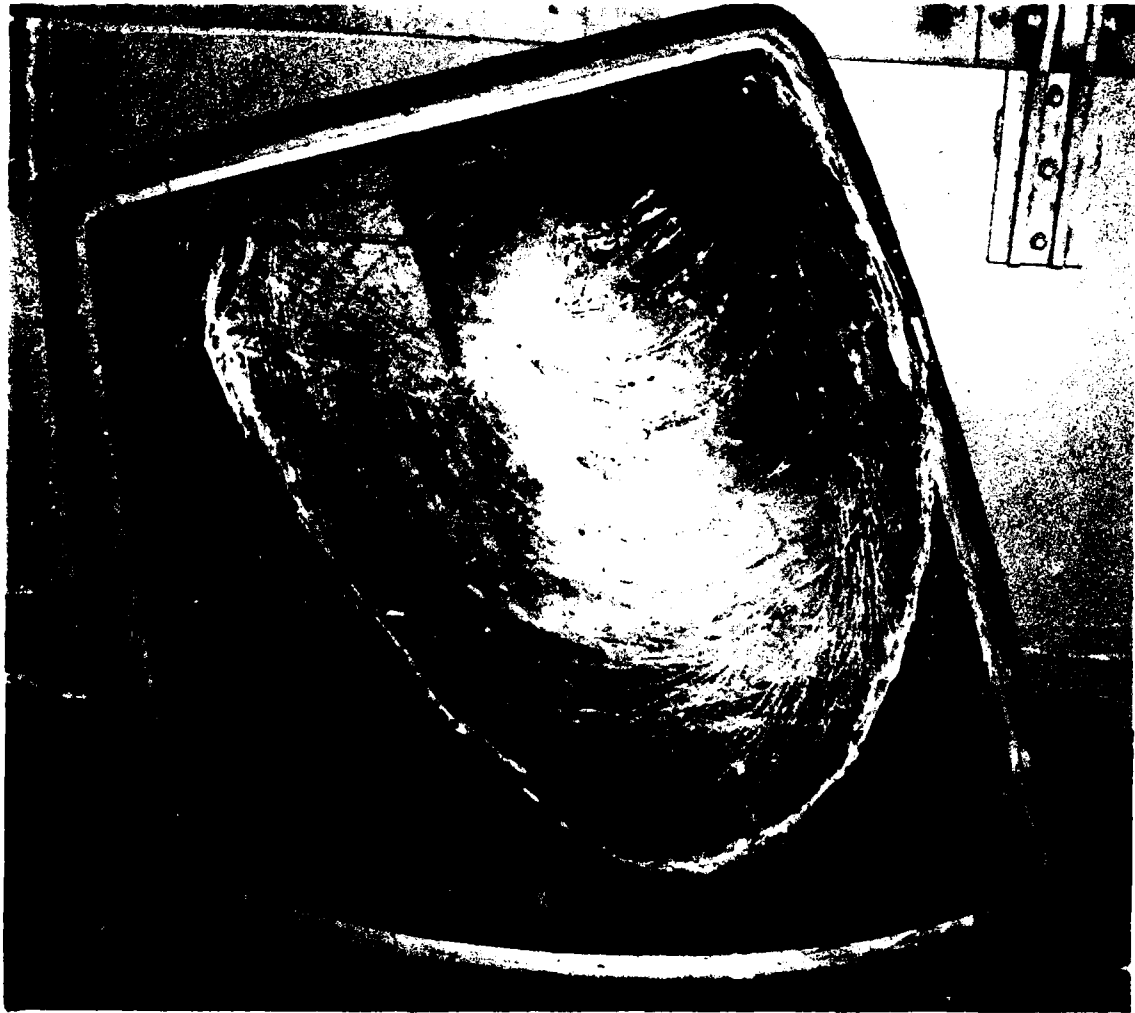
(1) Shot 696: Sierracin Left-Hand Canopy S/N 159. Massive failure of the canopy occurred with large amounts of bird debris penetrating into the crew module. Failure initially began in the forward right-hand corner, traveling along the center beam, across the top of the canopy, and then forward to the windshield aft arch. Review of the high-speed movie film showed extensive deflection of the canopy prior to initiation of the failure. Figures 15 and 16 show the damage to the canopy.

Figure 16. Shot 696, Post Test Condition of Left Hand Canopy

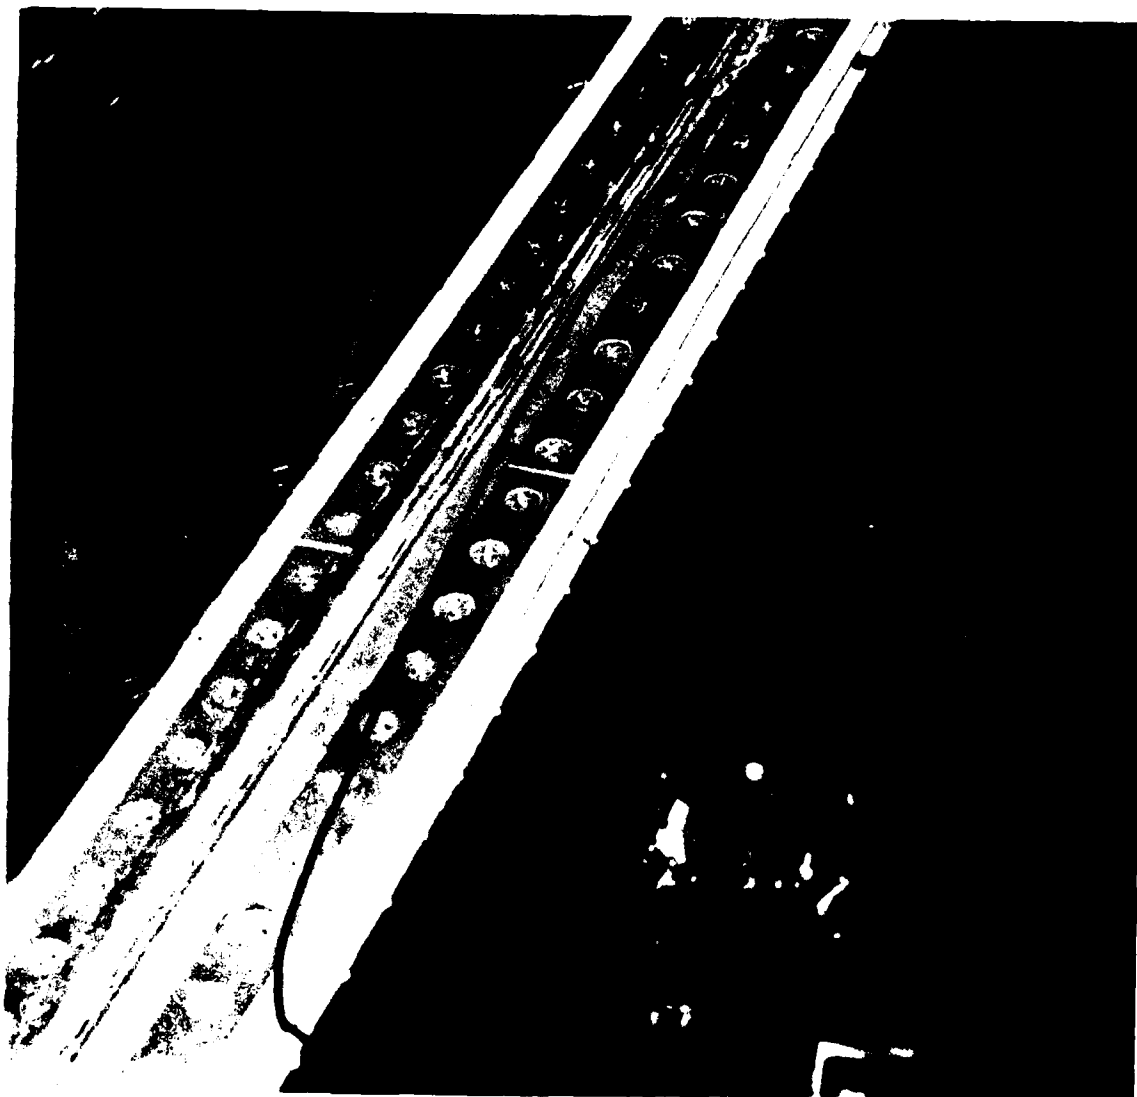
A summary of the tests are contained in Table A-1. A brief description of the results is provided below. It should be noted from Table A-1 that the tests were performed at a 10% (or greater) reduction in impact velocity to allow for a measure of in-service aging effects. Even at this reduced velocity level, damage to the panels was significant. Figure A-1 shows typical pre-test delamination.

Figure A-1. Typical Delamination Patterns on Units Removed from Cannon AFB
